Boyd Intercounty Drain

Allegan and Ottawa Counties, Michigan

Engineer's Report – Concept Review Meeting
September 21, 2022

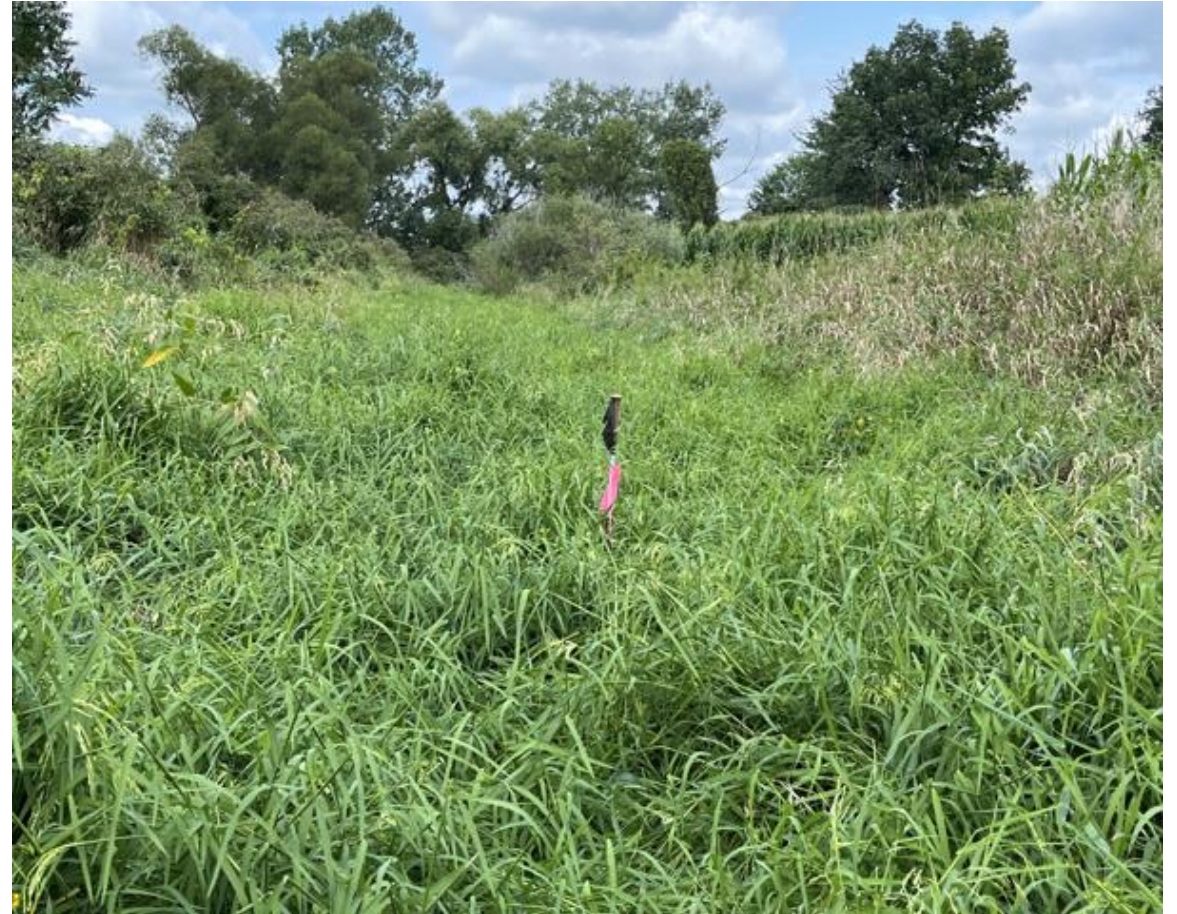
Sept. 2022 - Looking upstream toward confluence w/ Branch

- Very little base flow in Main and Branch
- Overgrown vegetation along banks and filling in channel
- Mucky bottom w/ 12" to 24" sediment
- Channel width 3' to 5'
- Linear wetland

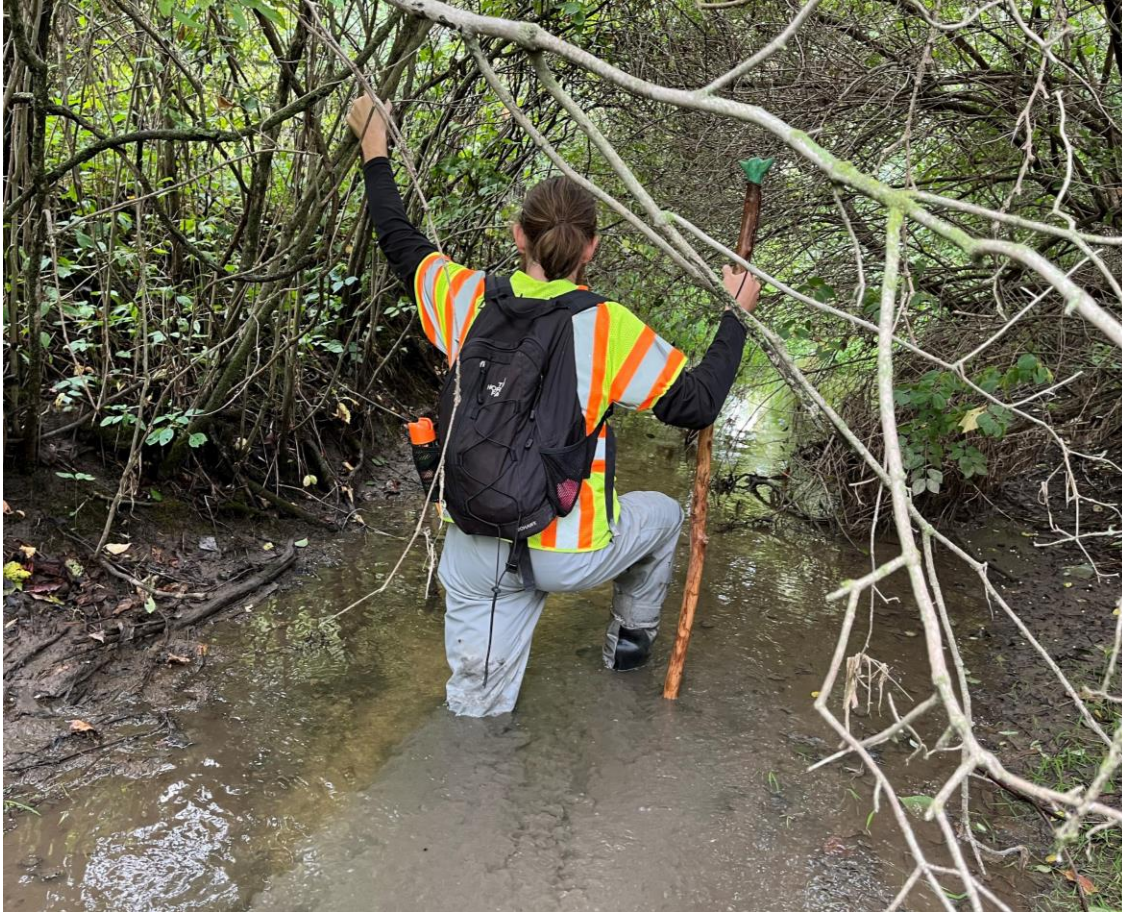
Knee-deep muck in upper reaches

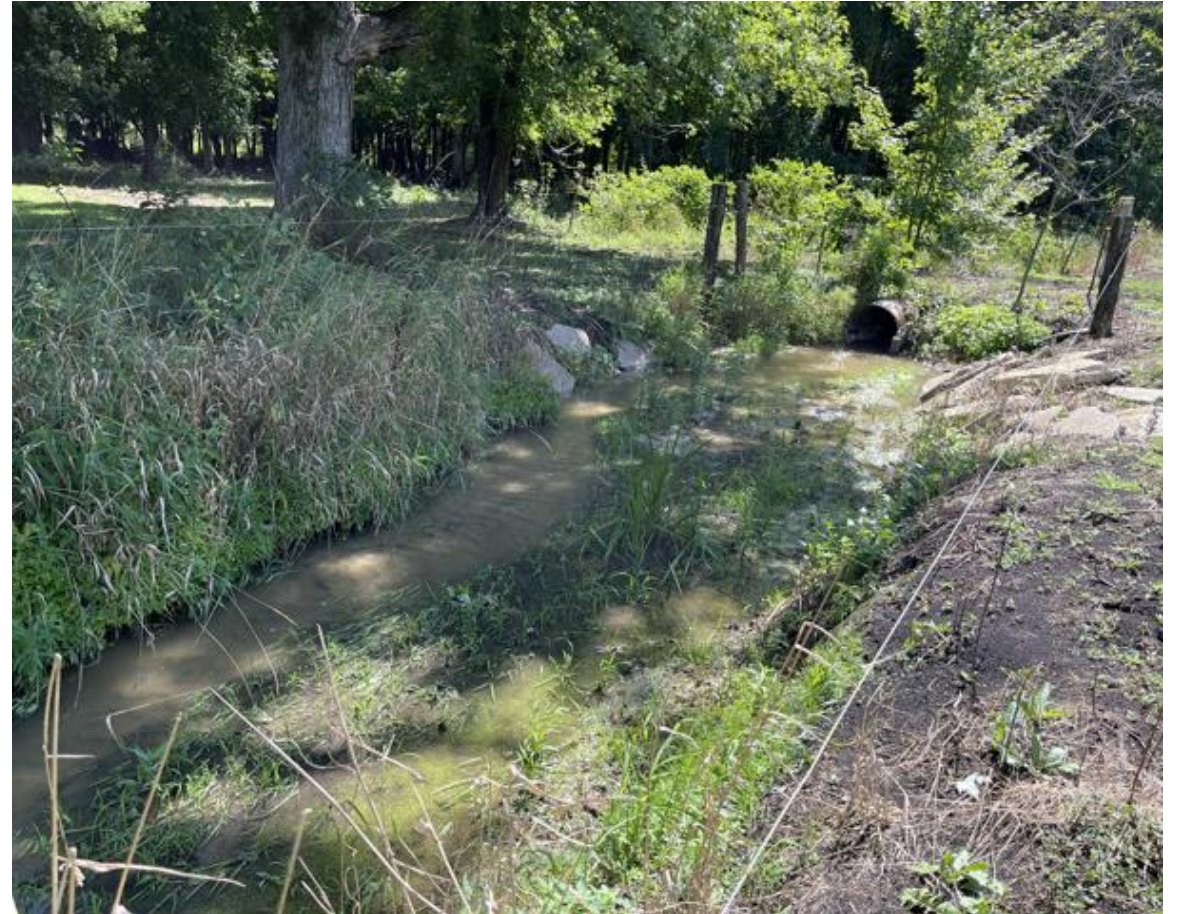
- Well to over-vegetated
- No downcutting
- No significant signs of erosion
- Intermittent mid-channel bars in lower reach above Ottogan Street – livestock access

Mid-channel bars Sta 16+50 in dredged stretch

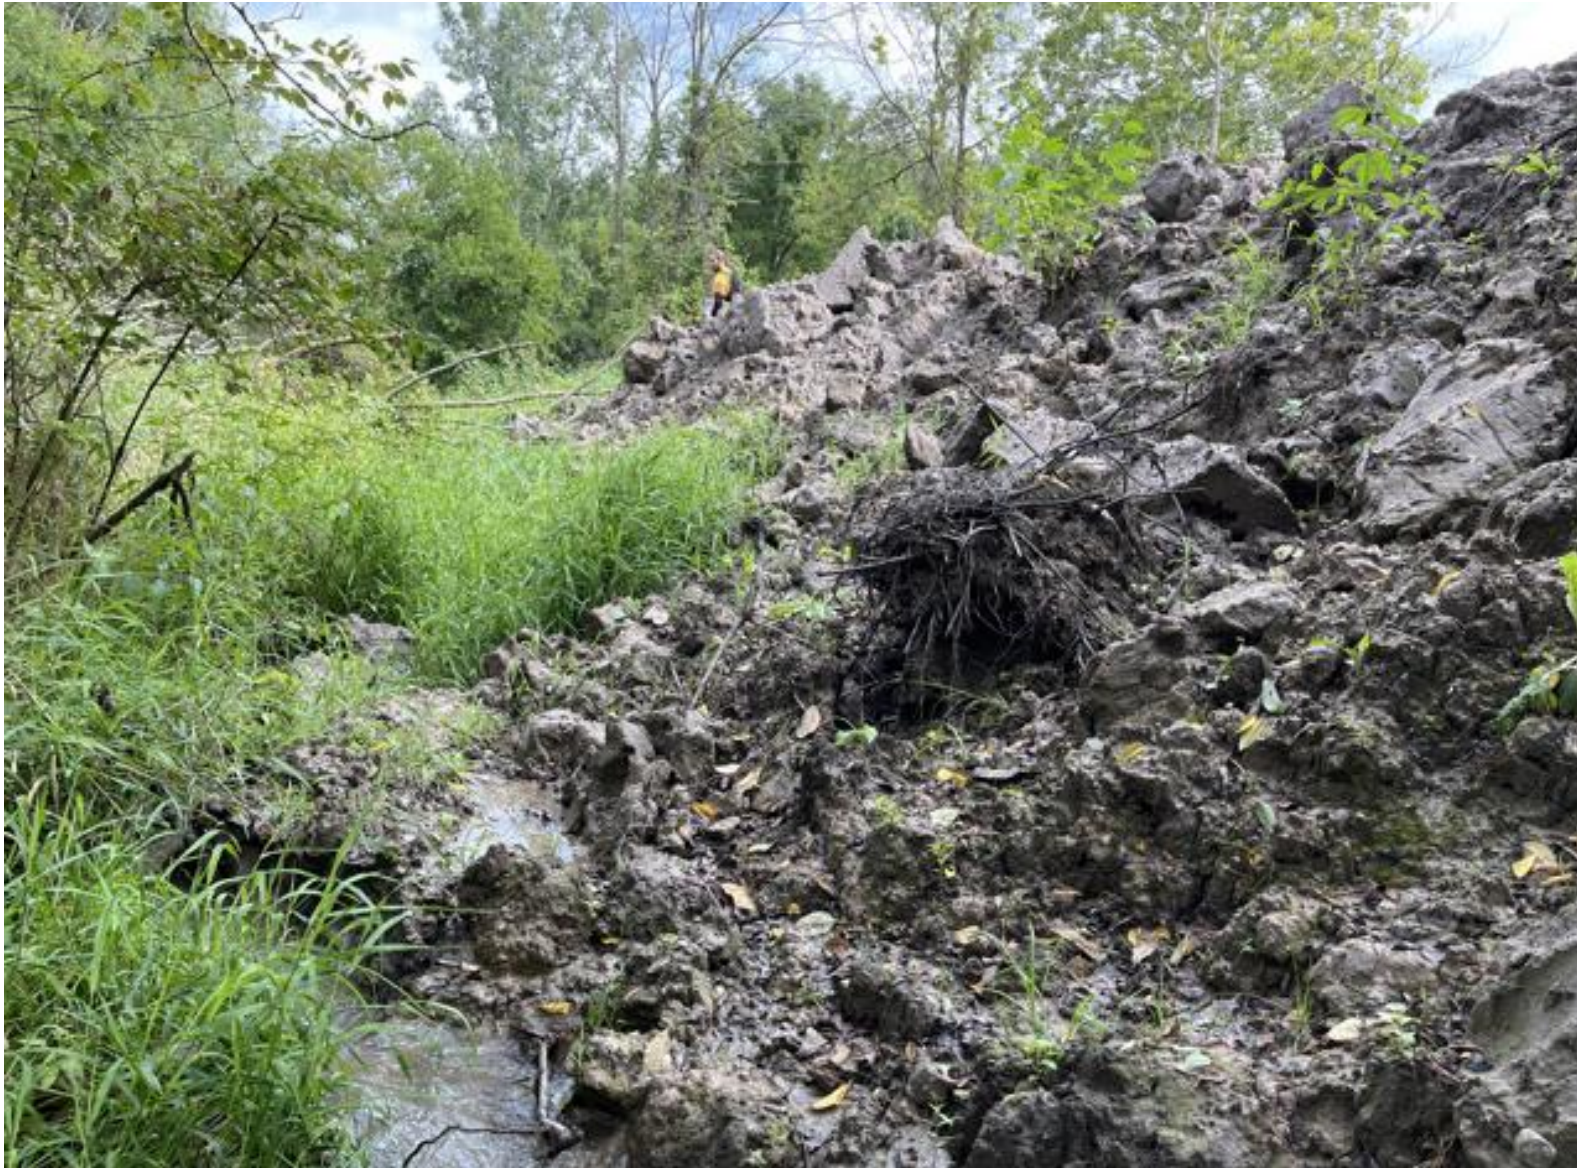
- Property Owner excavated pond at Sta 55+00
- Placed unstabilized spoils pile along drain
 - Encroachment of channel
 - Erosion and sedimentation

Spoils Pile as viewed from Drain

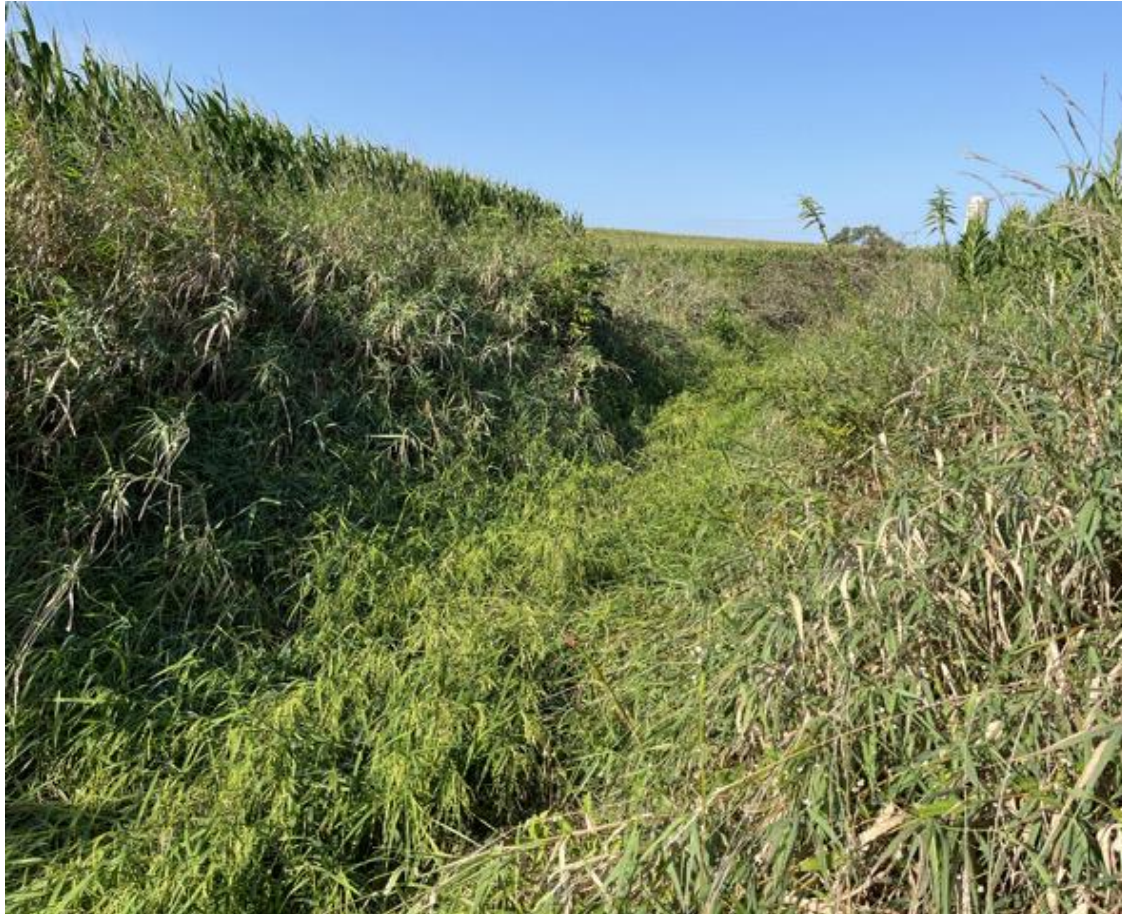
- Minimal woody debris work
 - Sta 50+00 to 64+00
 - Sta 70+00 to 75+00
- Channel choked by overgrown vegetation throughout

Vegetation Choked Channel at Sta 78+00

- Dip Out and Mow Banks
 - Sta 64+00 to 70+00
 - Sta 76+00 to 90+61
 - Branch Sta 0+00 to 14+00

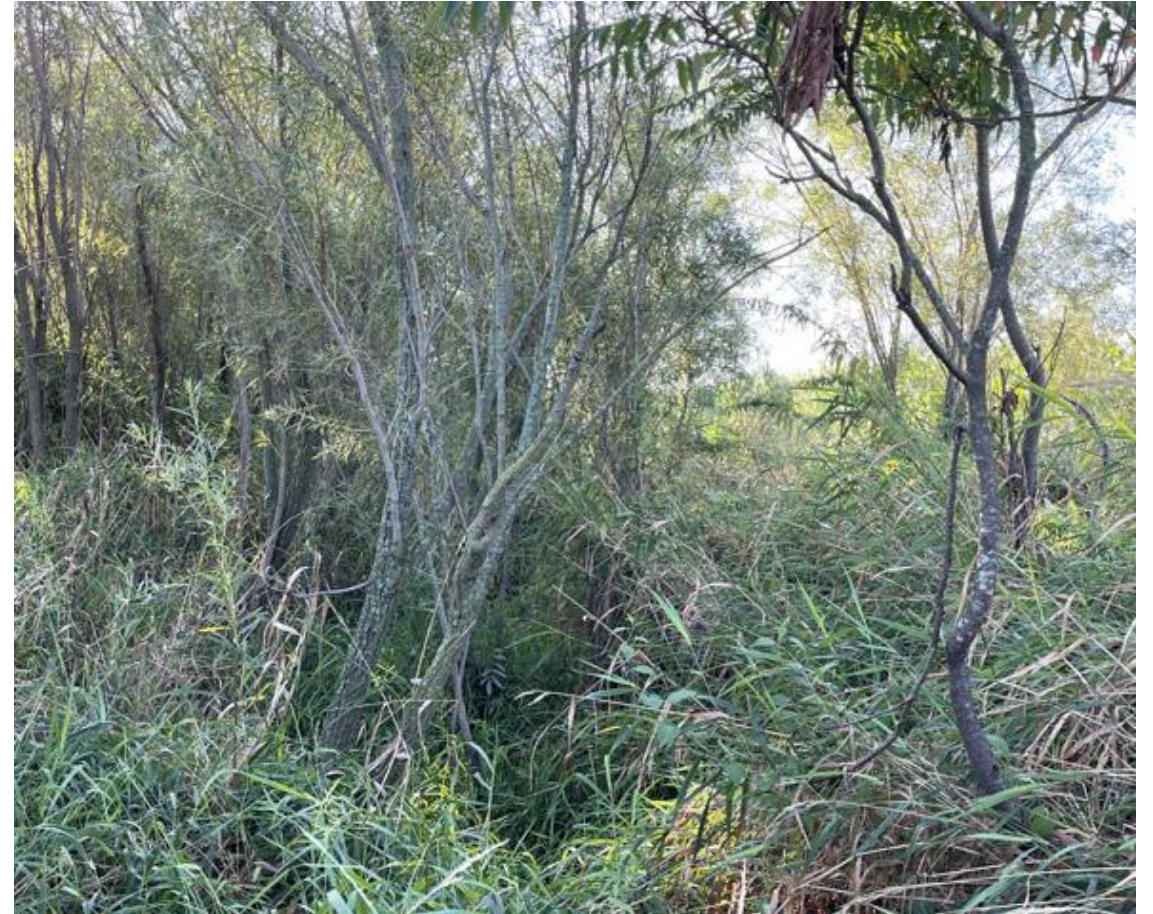
Woody Obstructions at Branch Sta 8+10

- Woody Debris Management
 - Sta 50+00 to 64+00
 - Sta 70+00 to 75+00

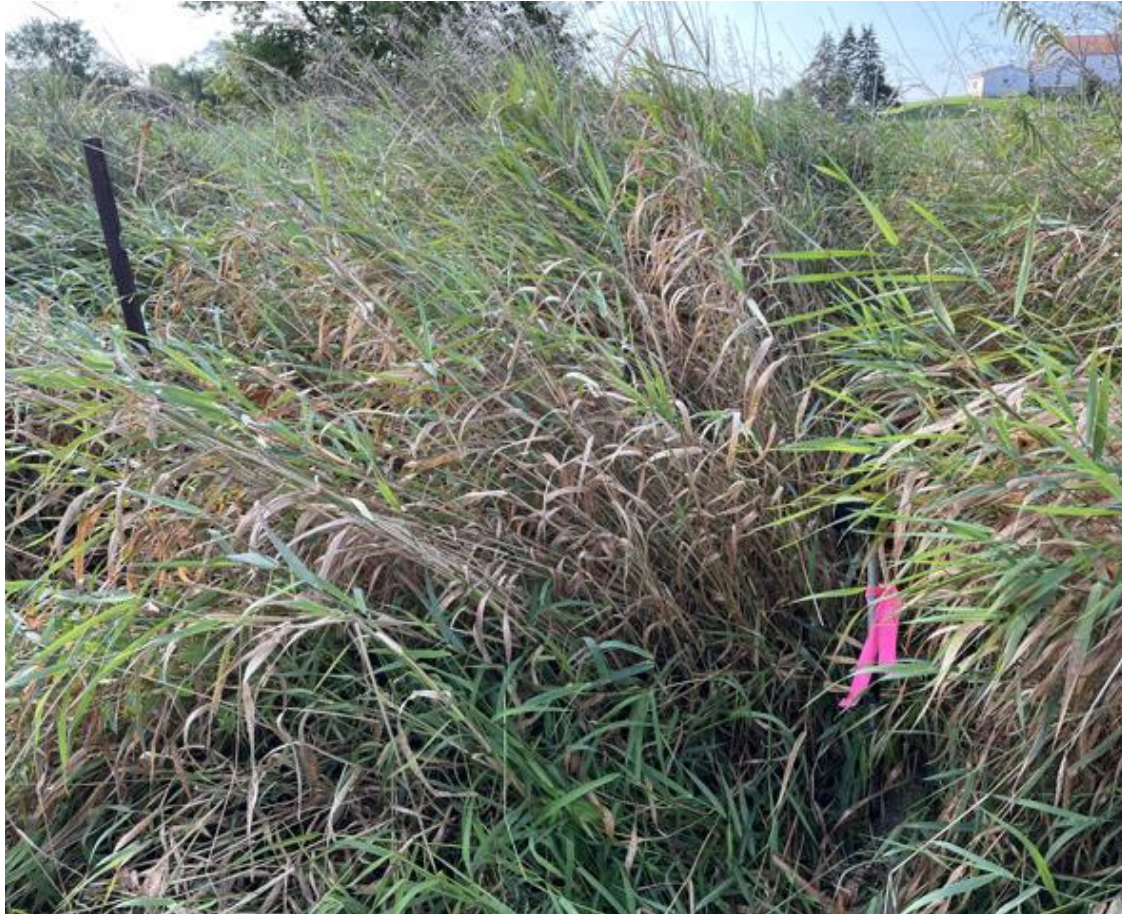
Possible Tile Outlet, Branch Sta 3+60

- Armored Spillways for gullies and tile drains
- Riprap at culvert inverts
- Native seeding w/ Mulch Blanket – Wetland Areas
- Open Channel Seeding – Non-Wetland Areas

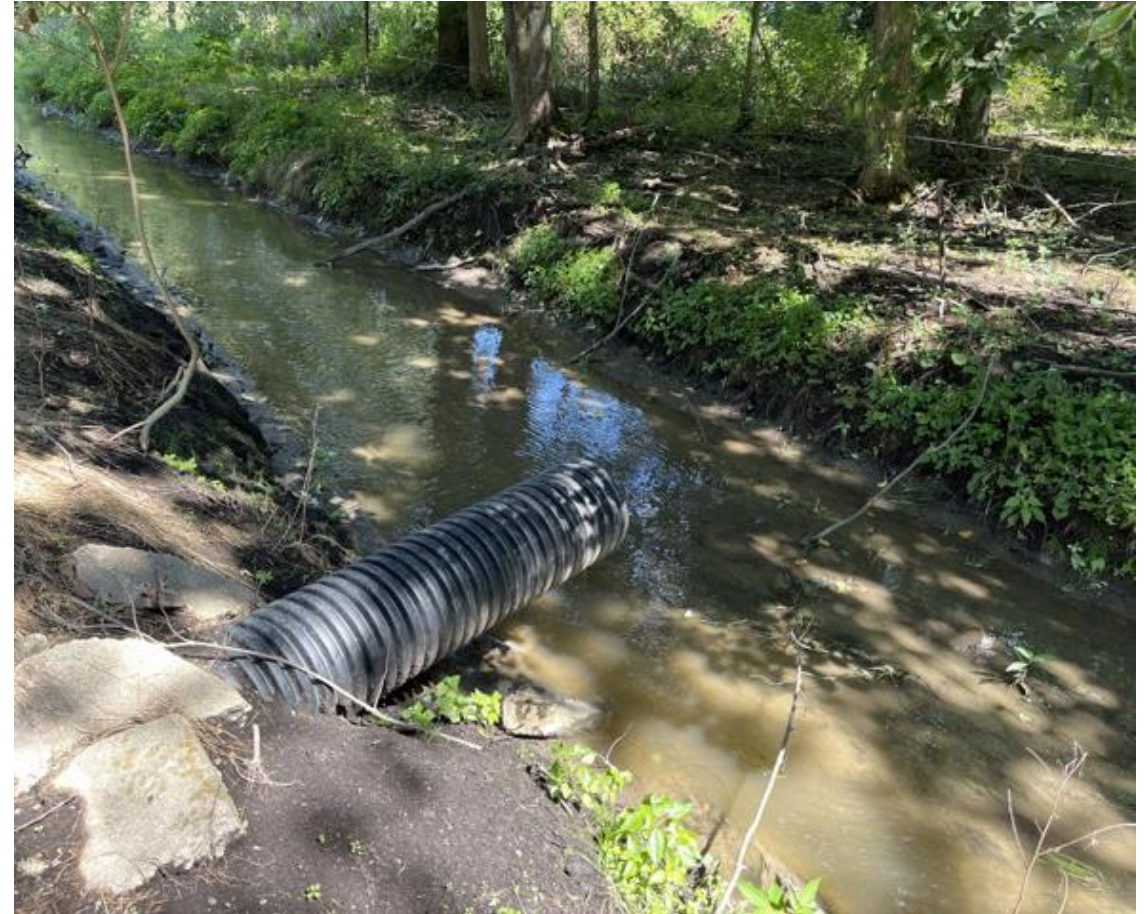
Tile Outlet, Station 12+40

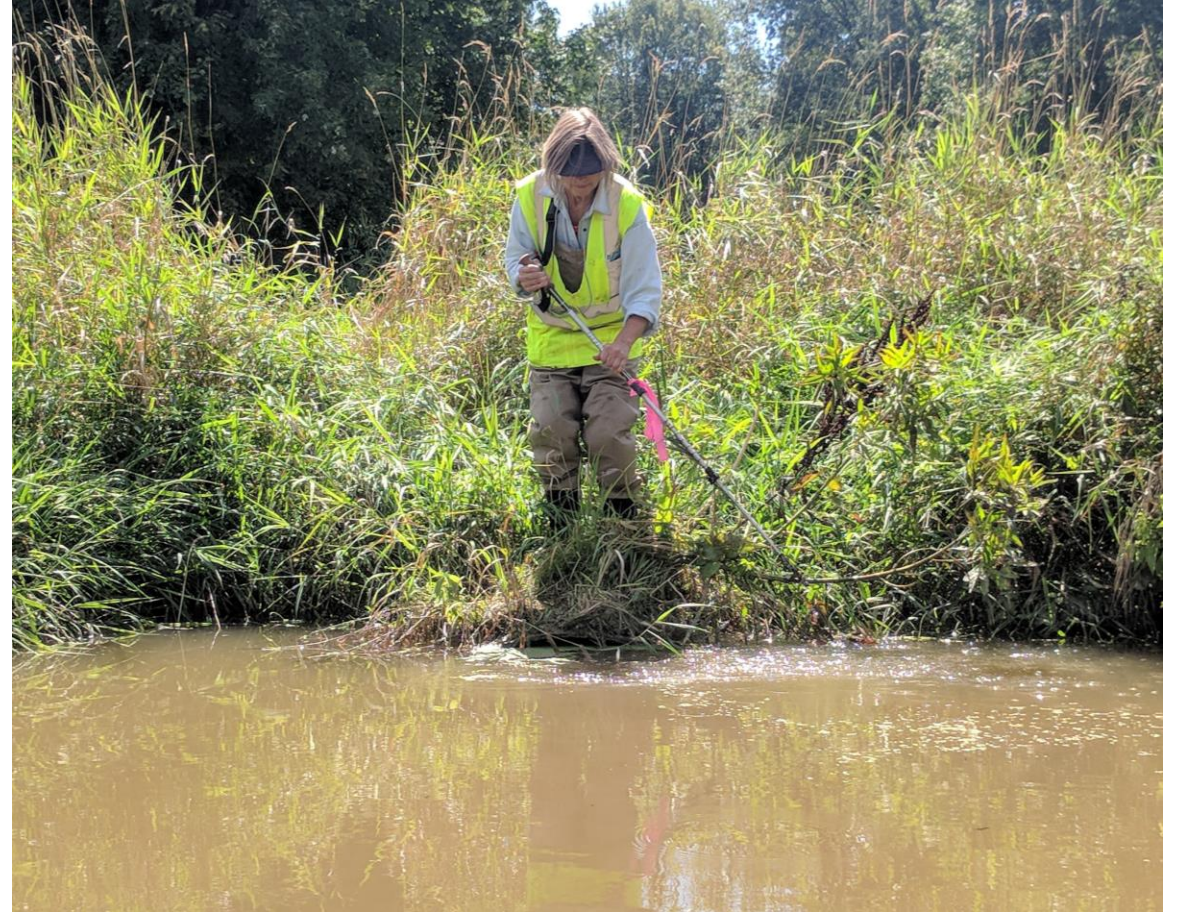
- Two county road crossings
- Four private crossings
- Crossings in generally fair to good condition
- Ottogan St crossing submerged under base flow conditions
 - Residents noted flooding during rain events
 - No evidence of settling

Ottogan St crossing. Submerged no flow base conditions.

- Ottogan St Culvert and Black Creek Confluence
 - Tributary flow dominant causing re-circulating eddy
 - Possible use of in-stream structure to reduce confluence angle
 - Requires Hydraulic Analysis

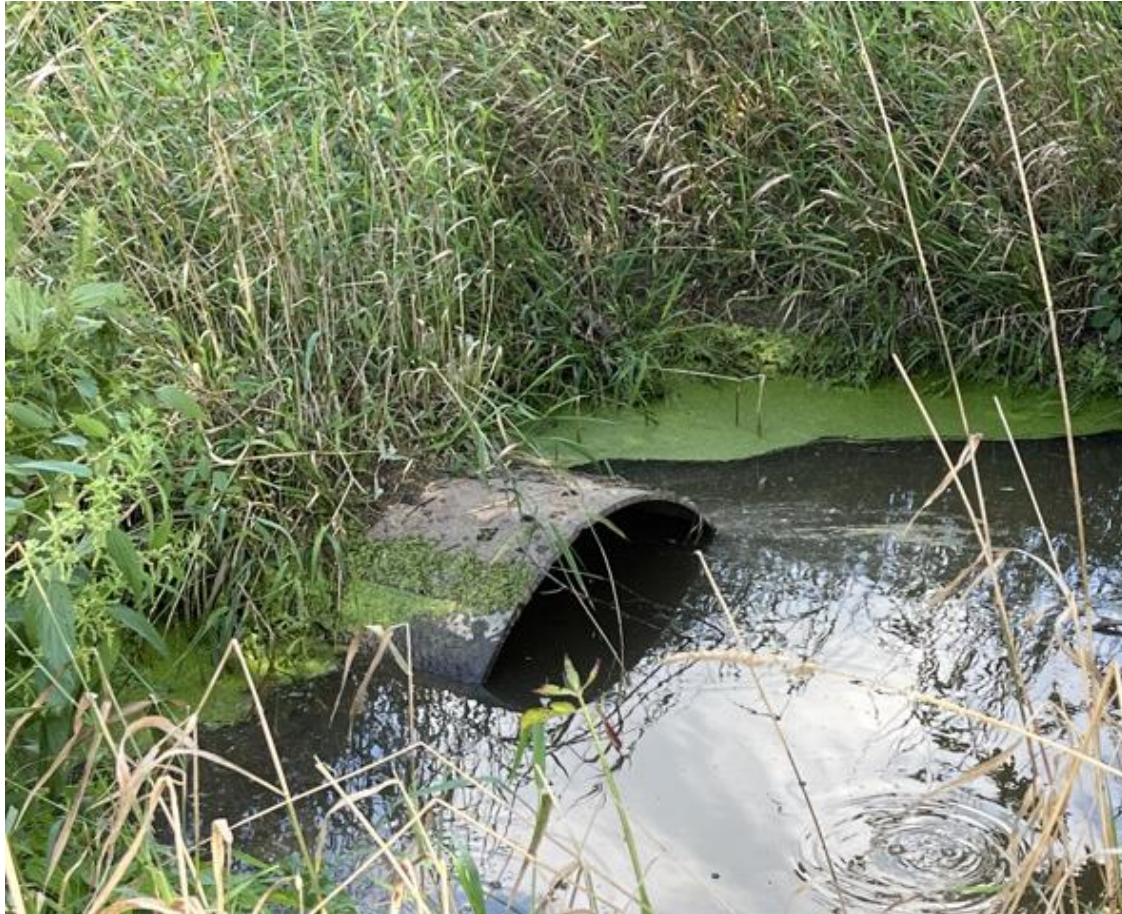
Ottogan St Culvert, partially submerged

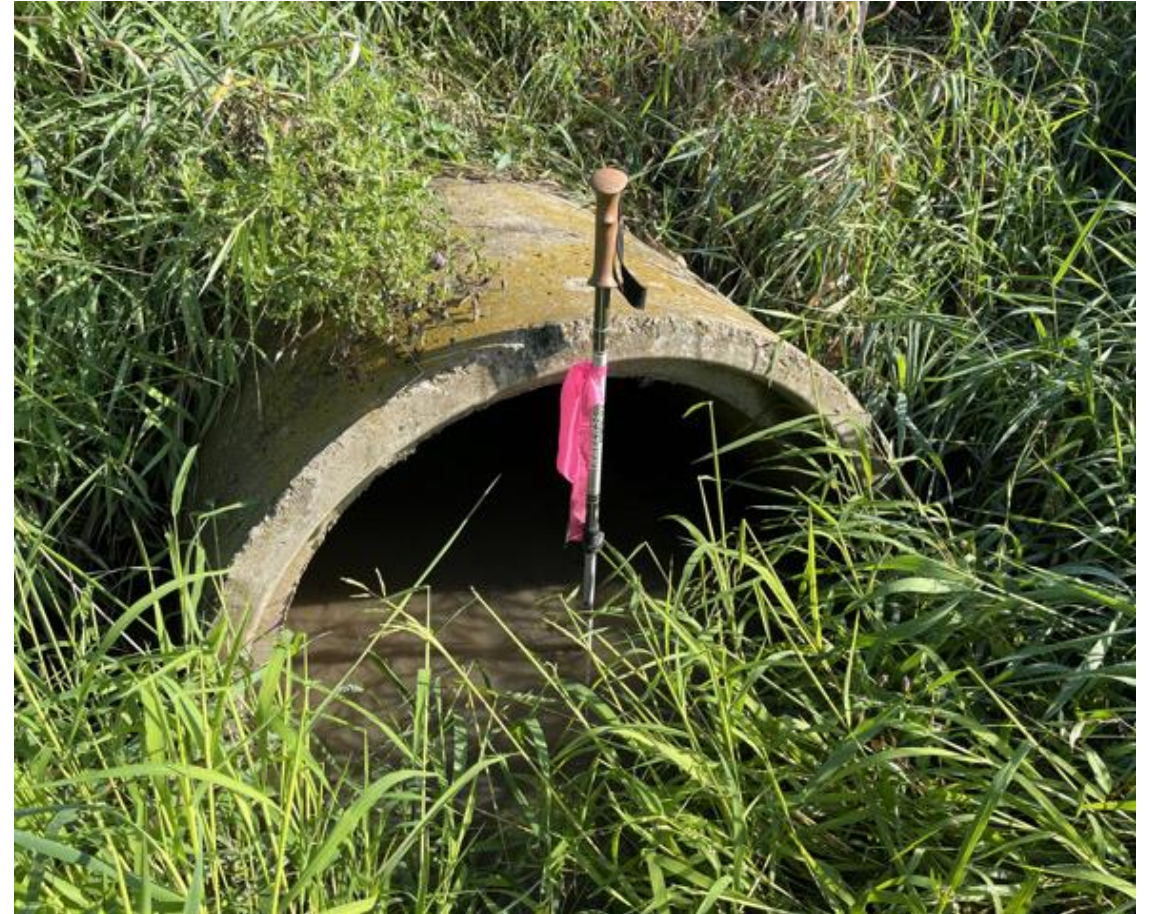
146th St Culvert, partially submerged, 21" sediment depth

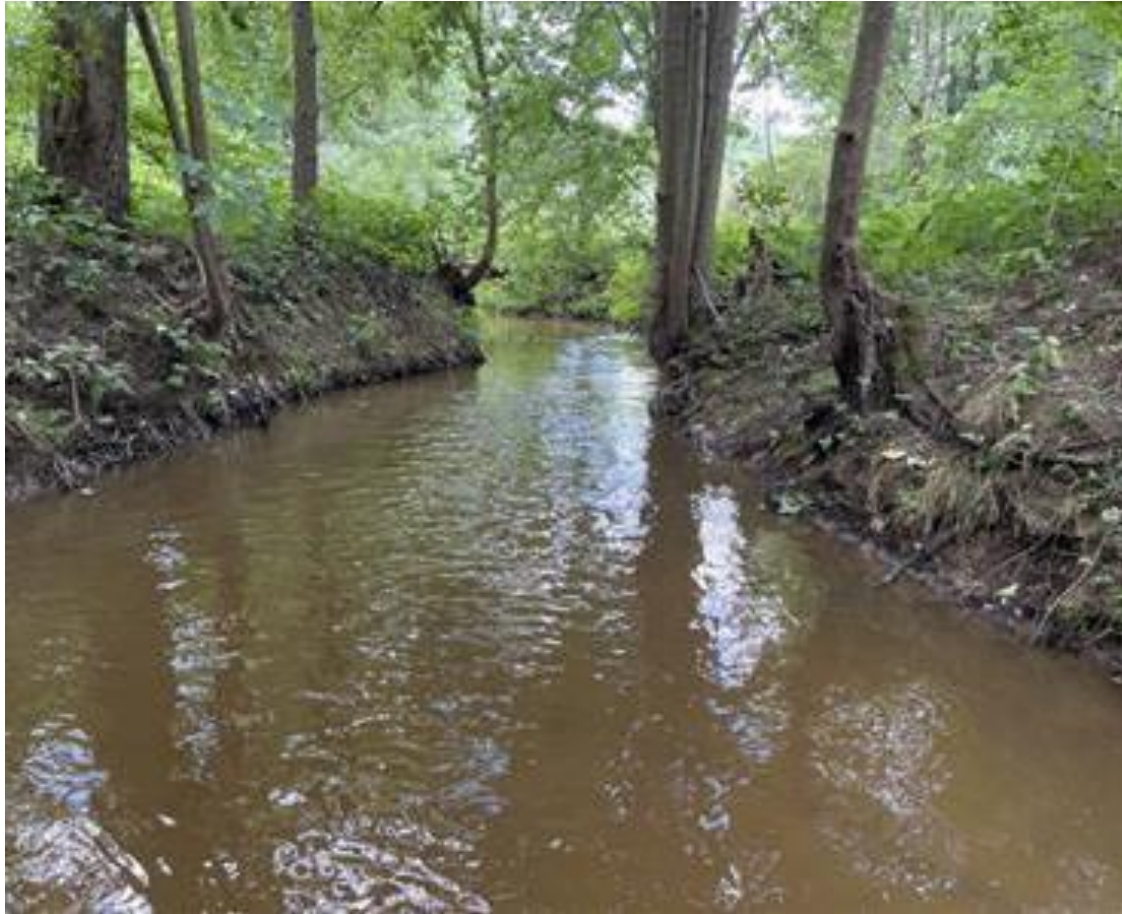
Black Creek – no obstructions; good flow

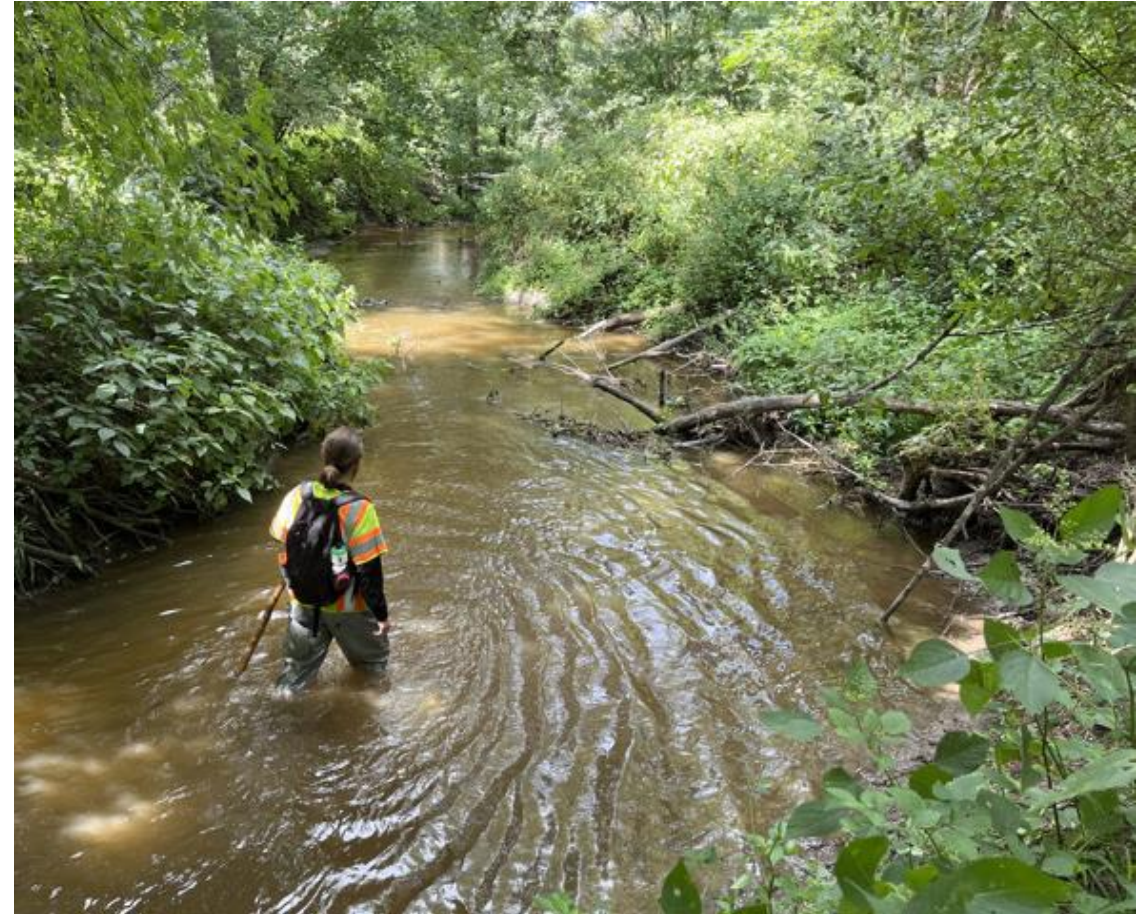
Black Creek – minor woody material; good flow

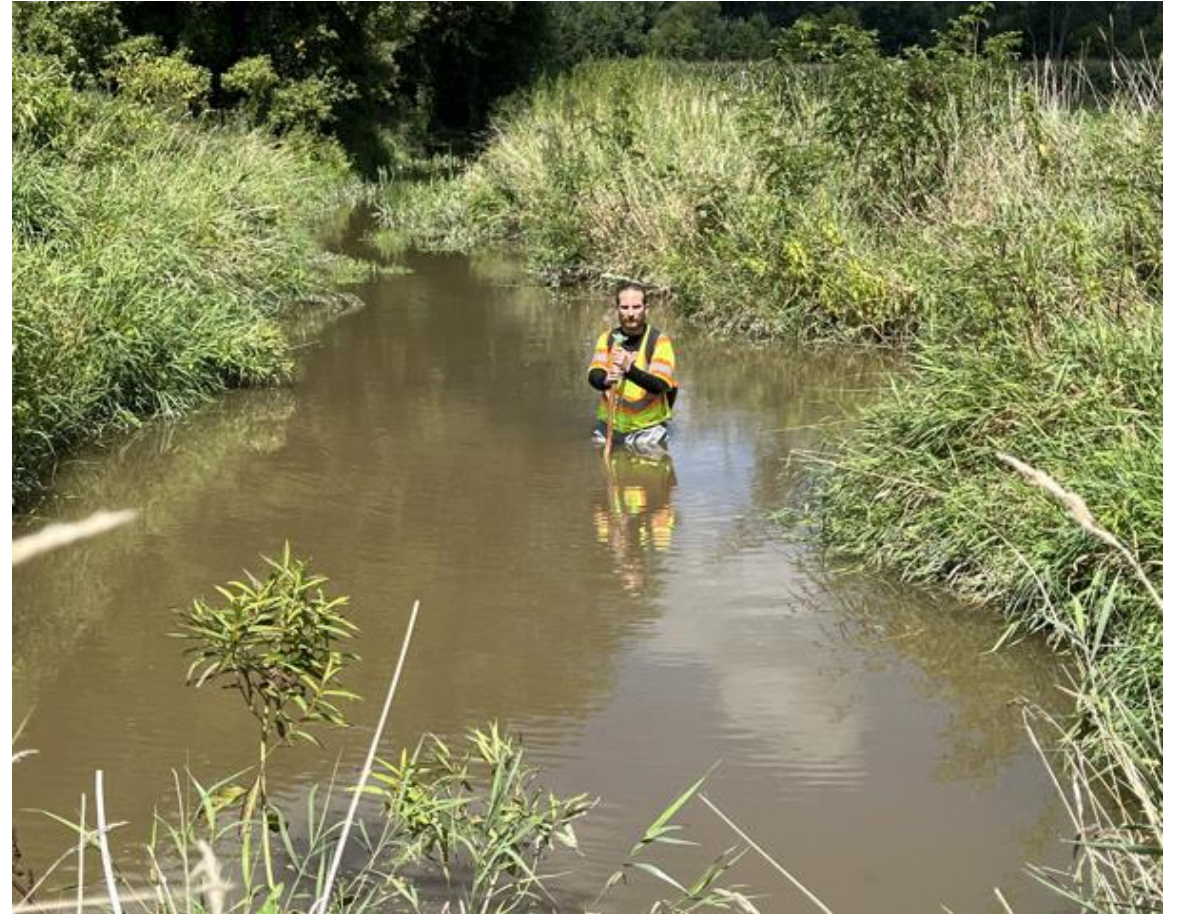
- Sediment depths of 12 in to 24 in throughout
- Isolated areas of woody debris
- Overgrown vegetation on banks and channel
- Tailwater effect at Black Creek prevents flow in Boyd

Mucky bottom and minimal baseflow DS of Ottogan St

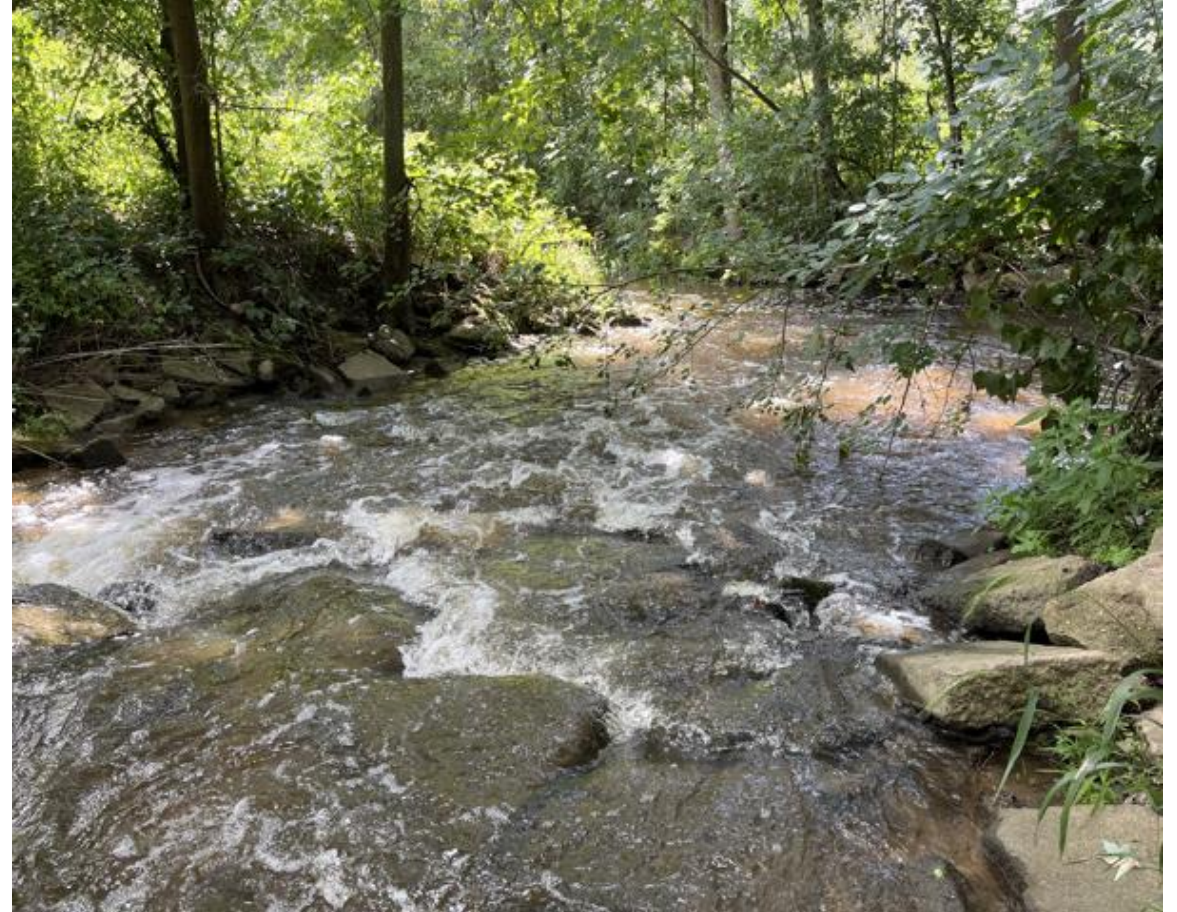
Tributary Flow from Black Creek
