October 1, 2019

Warber Drain Board of Determination

Warber Drain

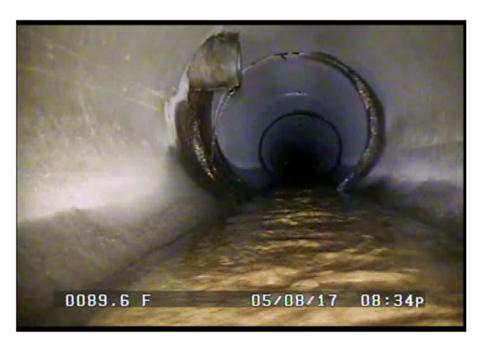
Protruding tap and mineral deposit buildup (encrustation) at joint.

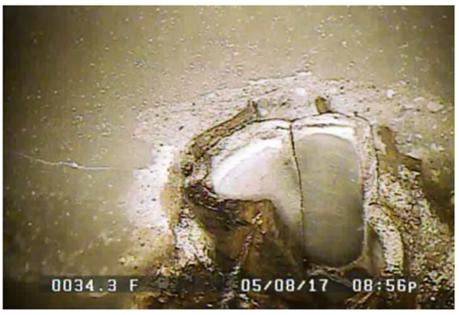
Cracked/Crushed/Collapsed Blind Taps are common in the Robbins Road Warber Drain storm sewer.

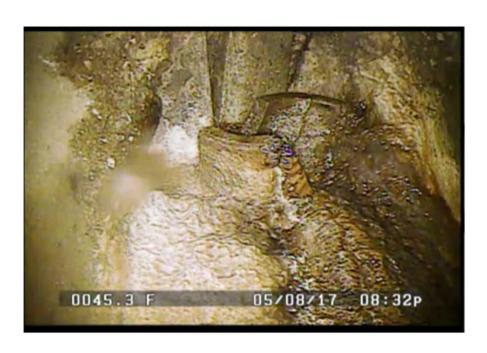
Collapsed protruding tap. These taps are located nearly entirely on the south side of the road and do not appear to have been properly sealed, and thus allow sediment to enter the storm sewer.

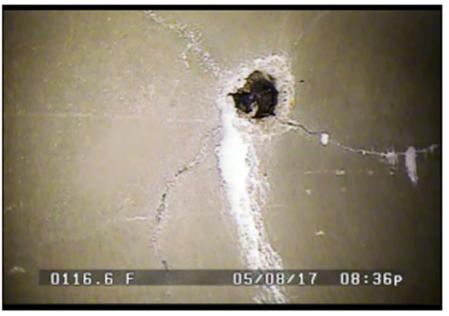
Cracking around lift hole of the 30 inch storm sewer.

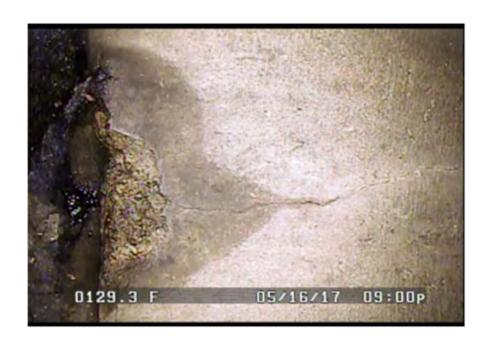
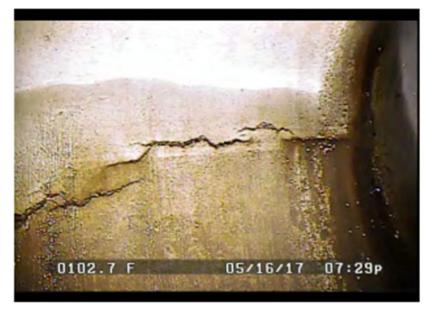
12 inch (left) and 15 inch (right) non-reinforced concrete storm sewer has numerous sections with cracking, which deteriorates the structural strength of the pipe. This storm sewer is between Hopkins Street and Beechtree Street.

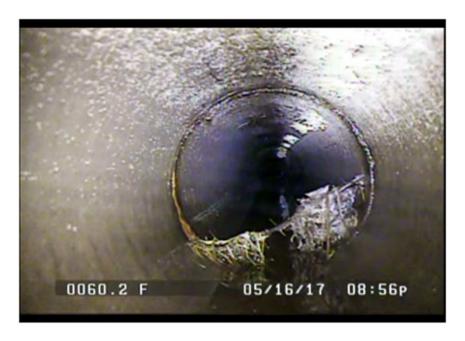
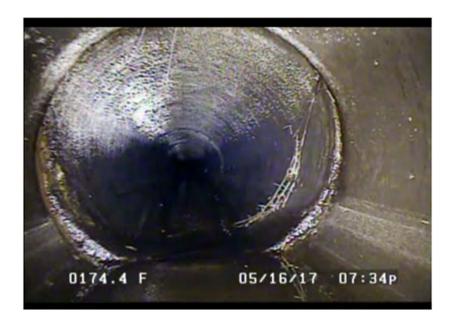
Roots in the joints of the 12 inch and 15 inch sections of non-reinforced concrete storm sewer between Hopkins Street and Beechtree Street. Roots impact the flow capacity of the storm sewer and indicate joint issues with the pipe.

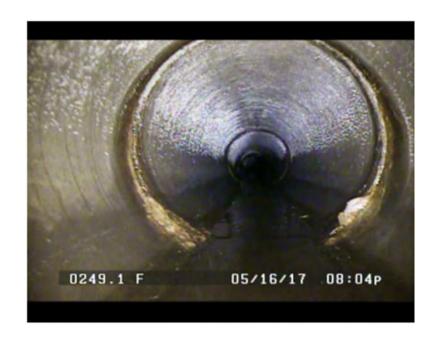
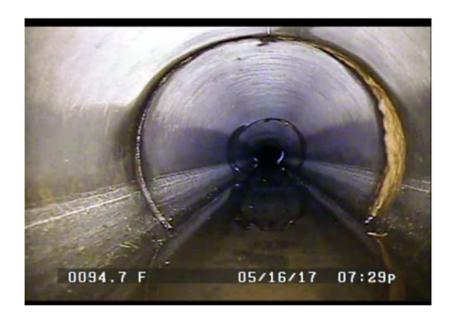
Mineral deposit buildups in the storm sewer can restrict flow in the storm sewer.

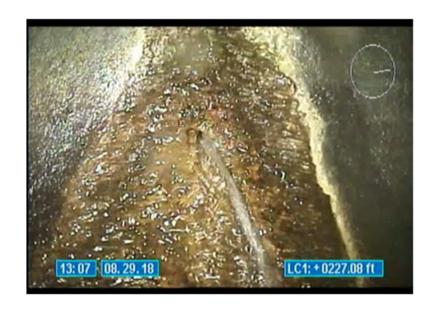
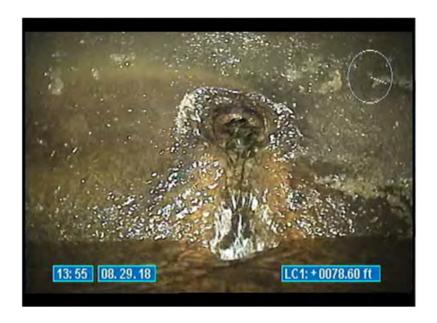
Infiltration through joints (photo on the left) and infiltration through a hole (photo on the right) in the 36 inch storm sewer.

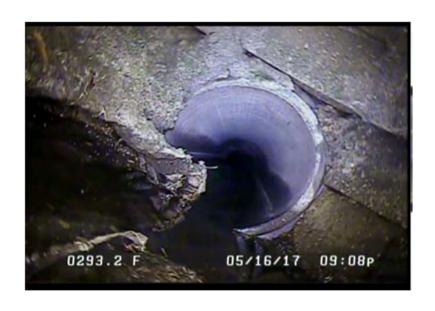
Mortar blocking inlet of pipe in manhole.

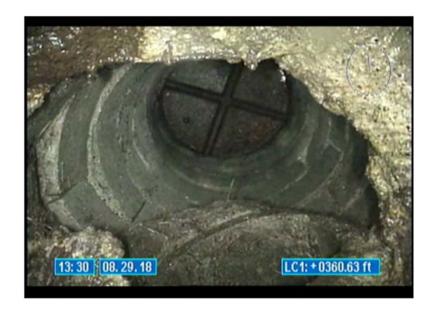
Block manhole structures are beginning to deteriorate.

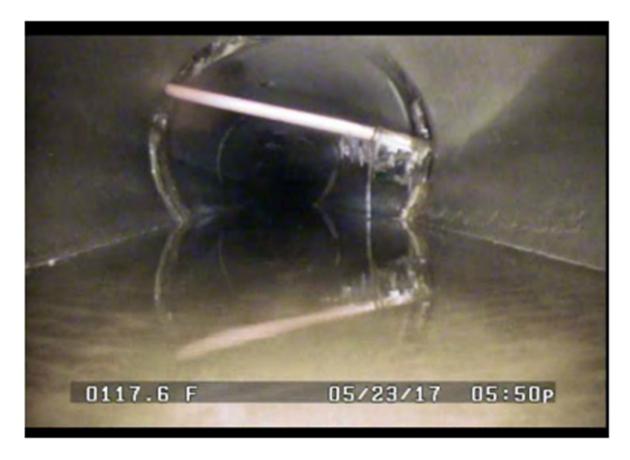
Gas line drilled through 30 inch storm sewer.

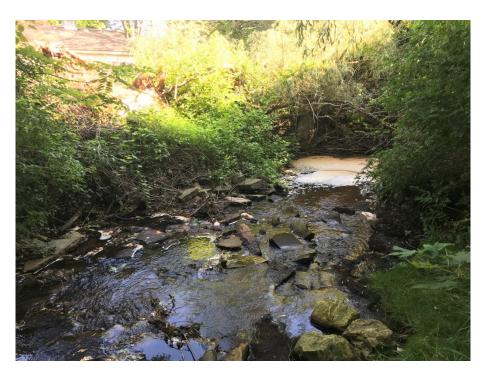
Debris (riprap) in drain and log jam downstream. Location is where school parking lot drains west towards Warber Drain.

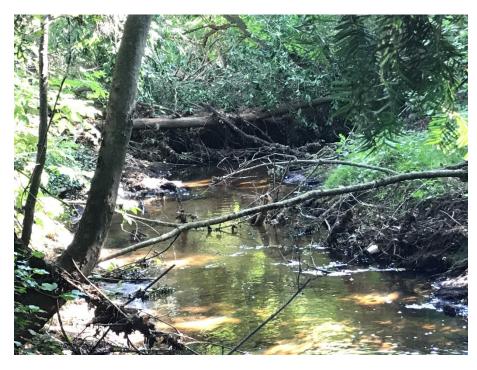
Fallen trees in drain near northwestern-most corner of parking lot

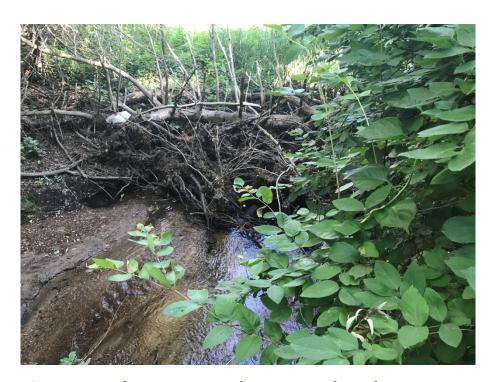
Log jam in drain near southwestern edge of soccer field fence

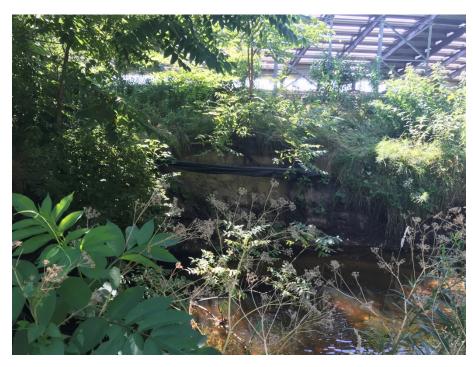
Bank sloughing

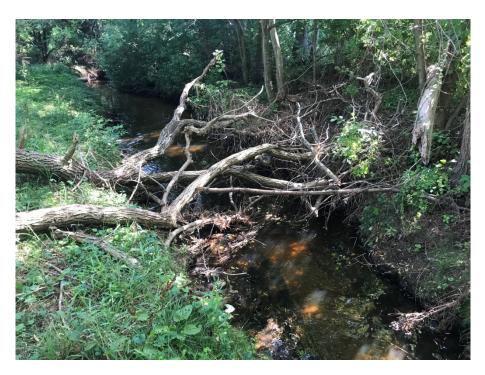
Log jam from fallen branches in river (see map). Branches appear to have fallen from willow tree on west bank.

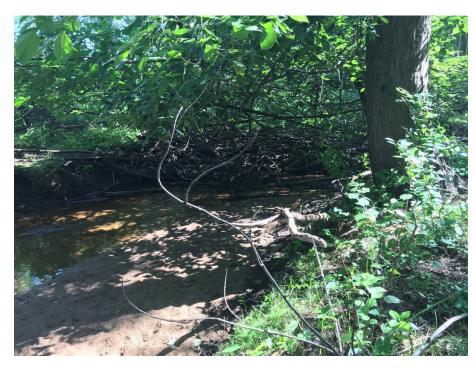
Woody debris near south bank of Warber Drain
