Boyd Intercounty Drain

Allegan and Ottawa Counties, Michigan

Engineer's Report – Concept Review Meeting
September 21, 2022

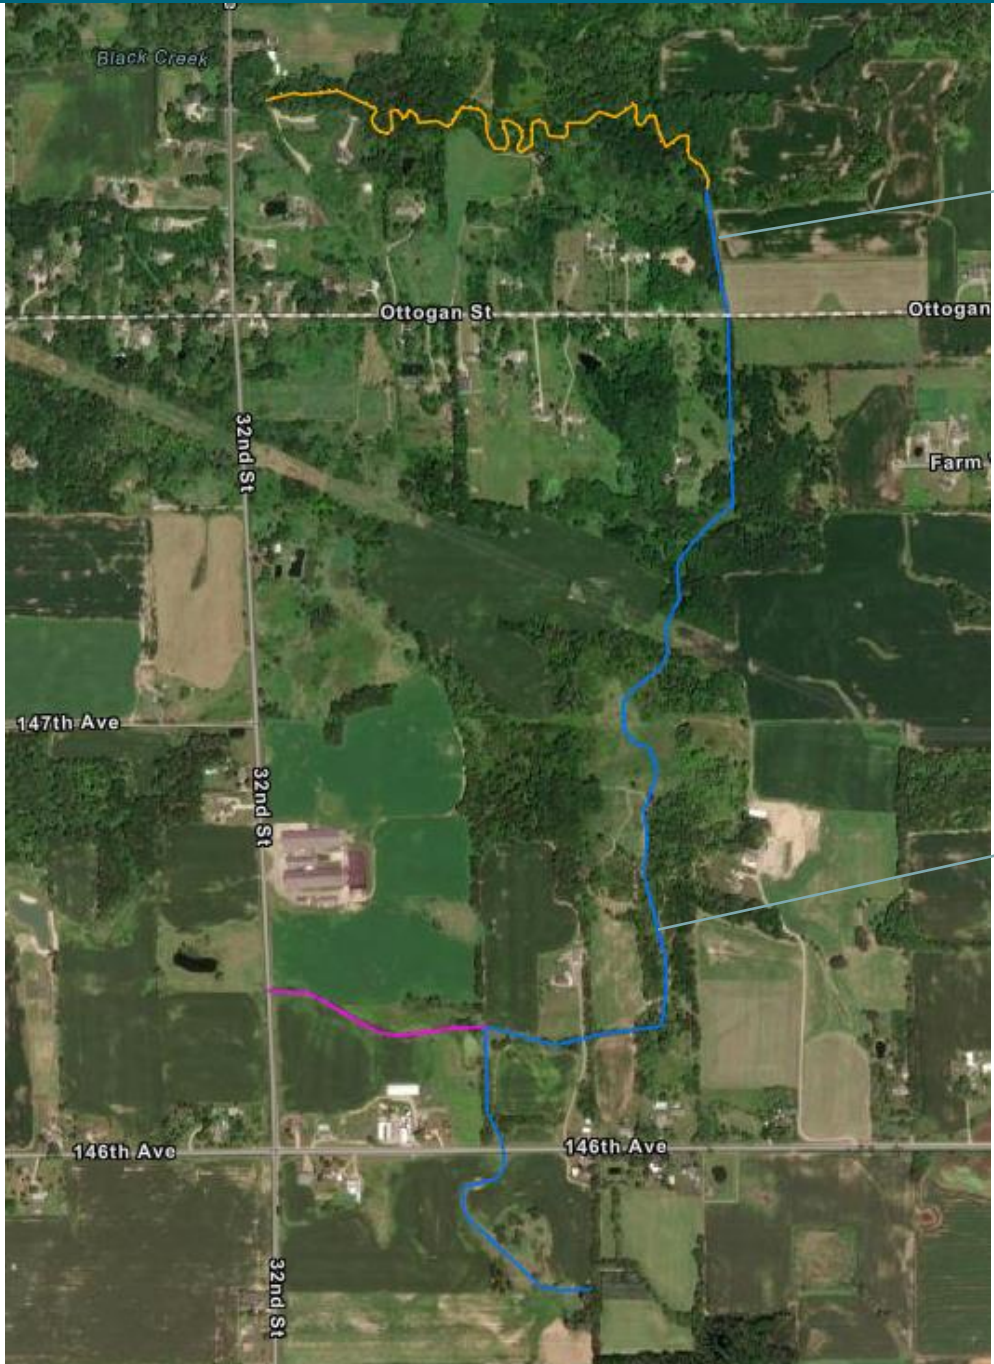
Sediment Basins

Sediment Basin
Sta 3+00

Sediment Basin
Sta 50+00

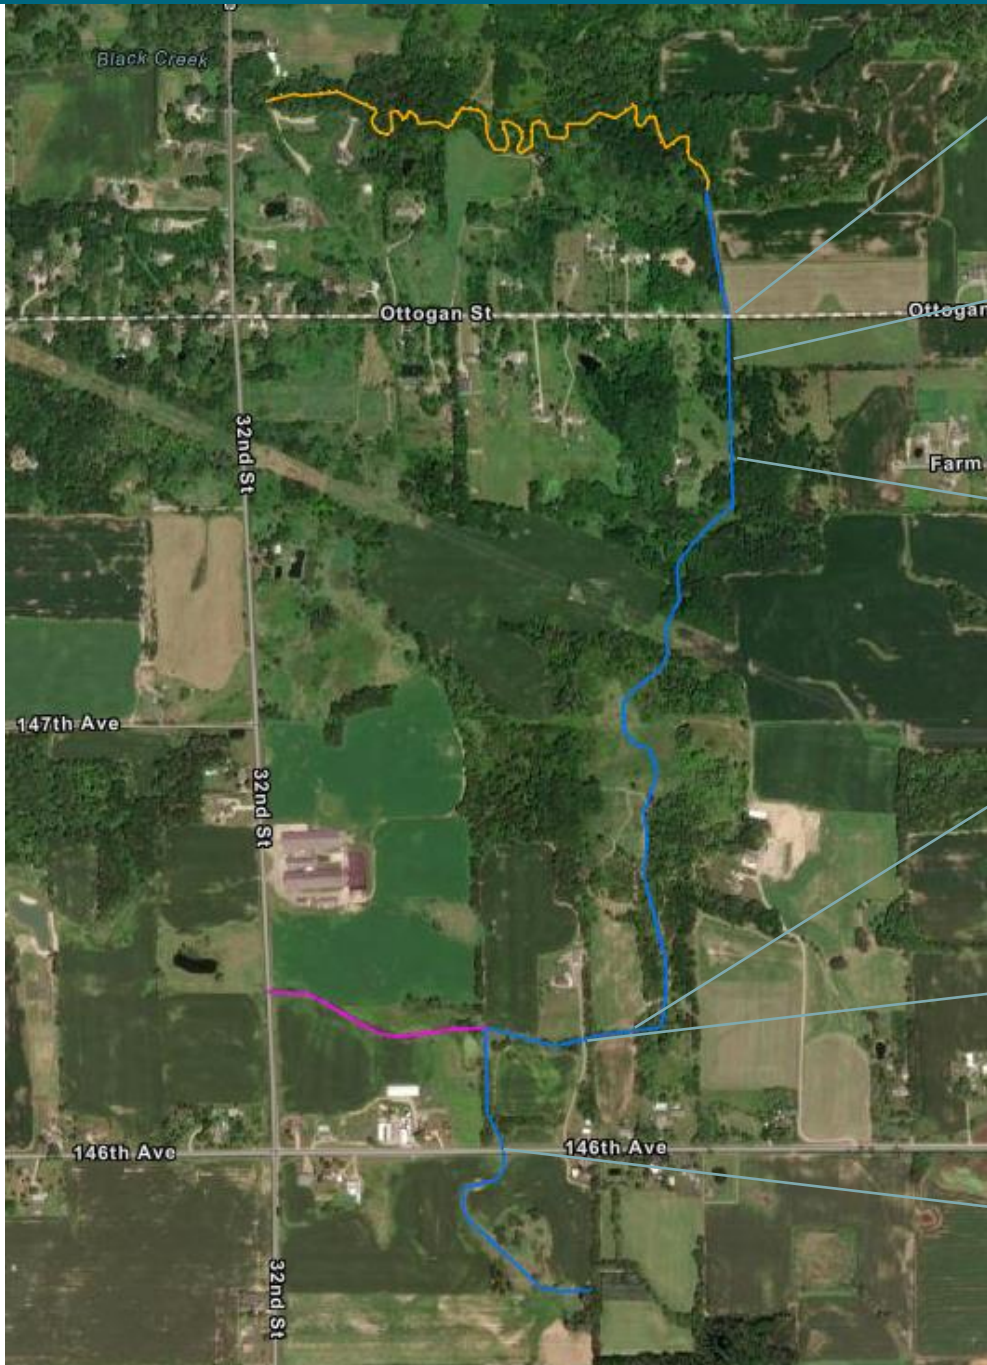
Ottogan Street, Sta 7+59
64 LF, 38"x60" Horizontal
Elliptical Concrete Pipe

Farm Crossing, Sta 10+60
44 LF, 29"x45" Horizontal
Elliptical Concrete Pipe

Farm Crossing, Sta 16+62
24 LF, 29"x45" Horizontal
Elliptical Concrete Pipe

Farm Crossing, Sta 58+25
30" CPP, Length Unknown
(Not on 2002 plans)

Farm Crossing, Sta 61+50
32 LF 36" CPP
(42" RCP per 2002 plans)

146th Ave, Sta 74+66
95 LF 36" RCP
(24" RCP per 2002 plans)

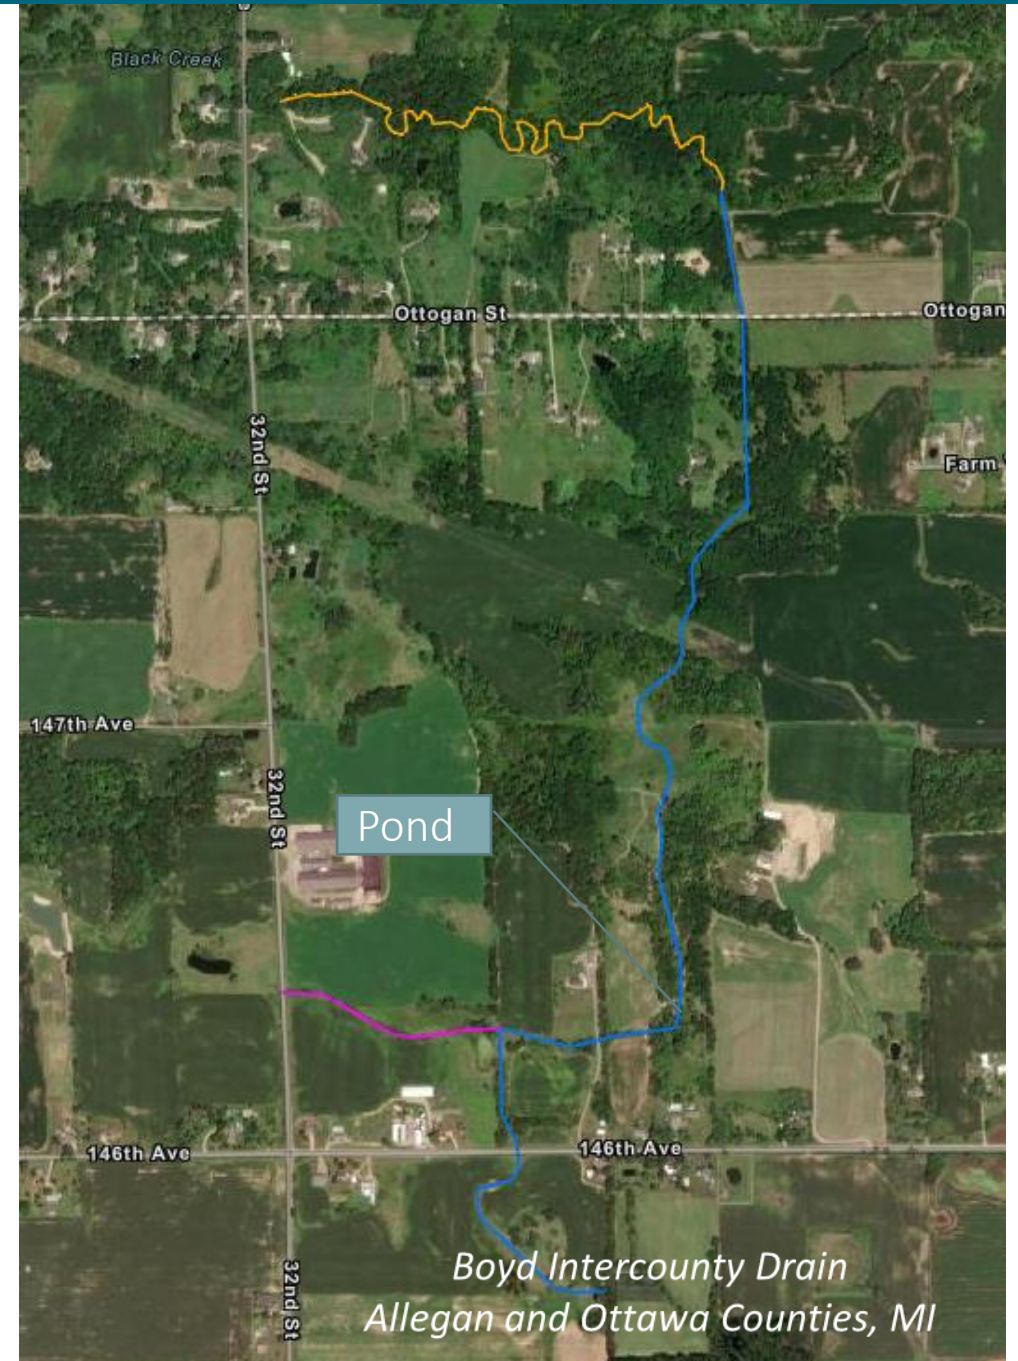
- Property Owner excavated pond at Sta 55+00
- Placed unstabilized spoils pile along drain
 - Encroachment of channel
 - Erosion and sedimentation

Spoils Pile as viewed from Drain

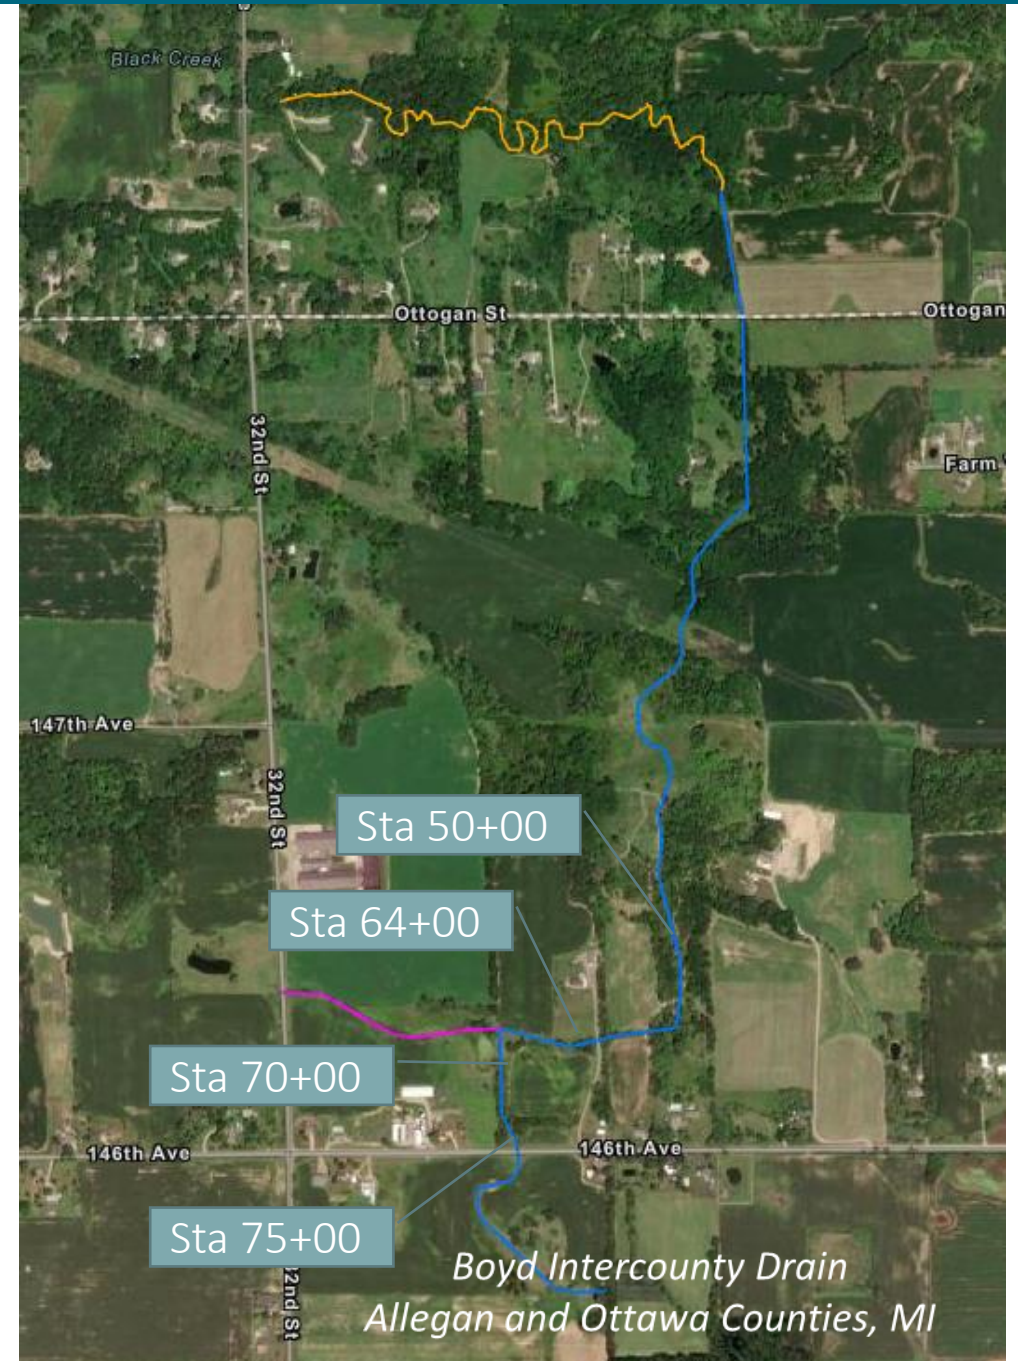
- Minimal woody debris work
 - Sta 50+00 to 64+00
 - Sta 70+00 to 75+00
- Channel choked by overgrown vegetation throughout

- Woody Debris Management
 - Sta 50+00 to 64+00
 - Sta 70+00 to 75+00

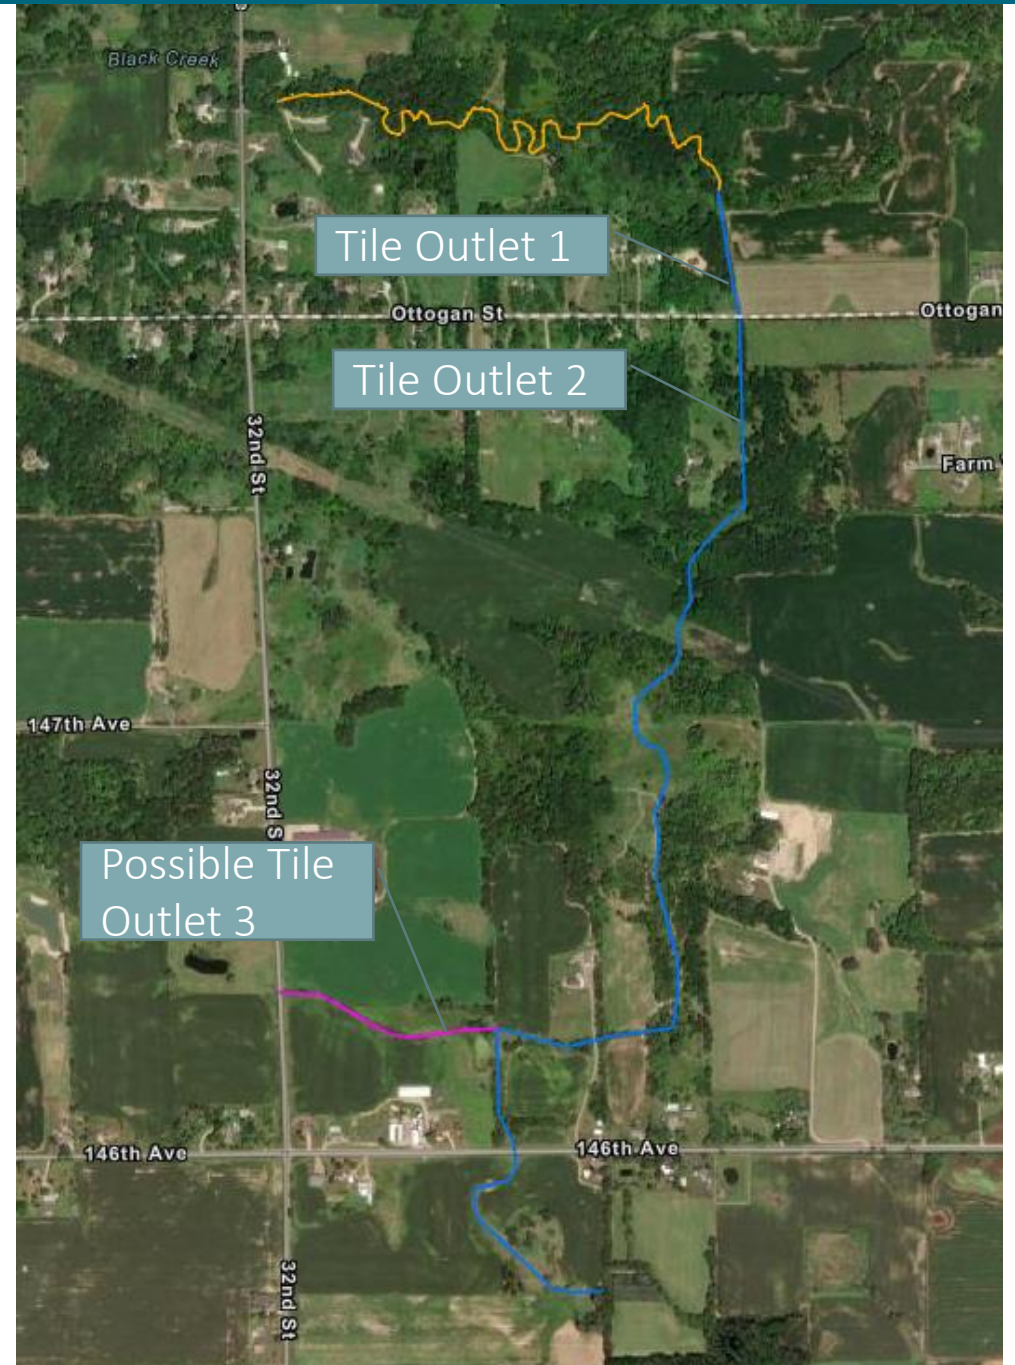
- Two tile outlets verified
- Additional tile outlets and gullies likely when vegetation dies/cut back

- Armored Spillways for gullies and tile drains
- Riprap at culvert inverts
- Native seeding w/ Mulch Blanket – Wetland Areas
- Open Channel Seeding – Non-Wetland Areas

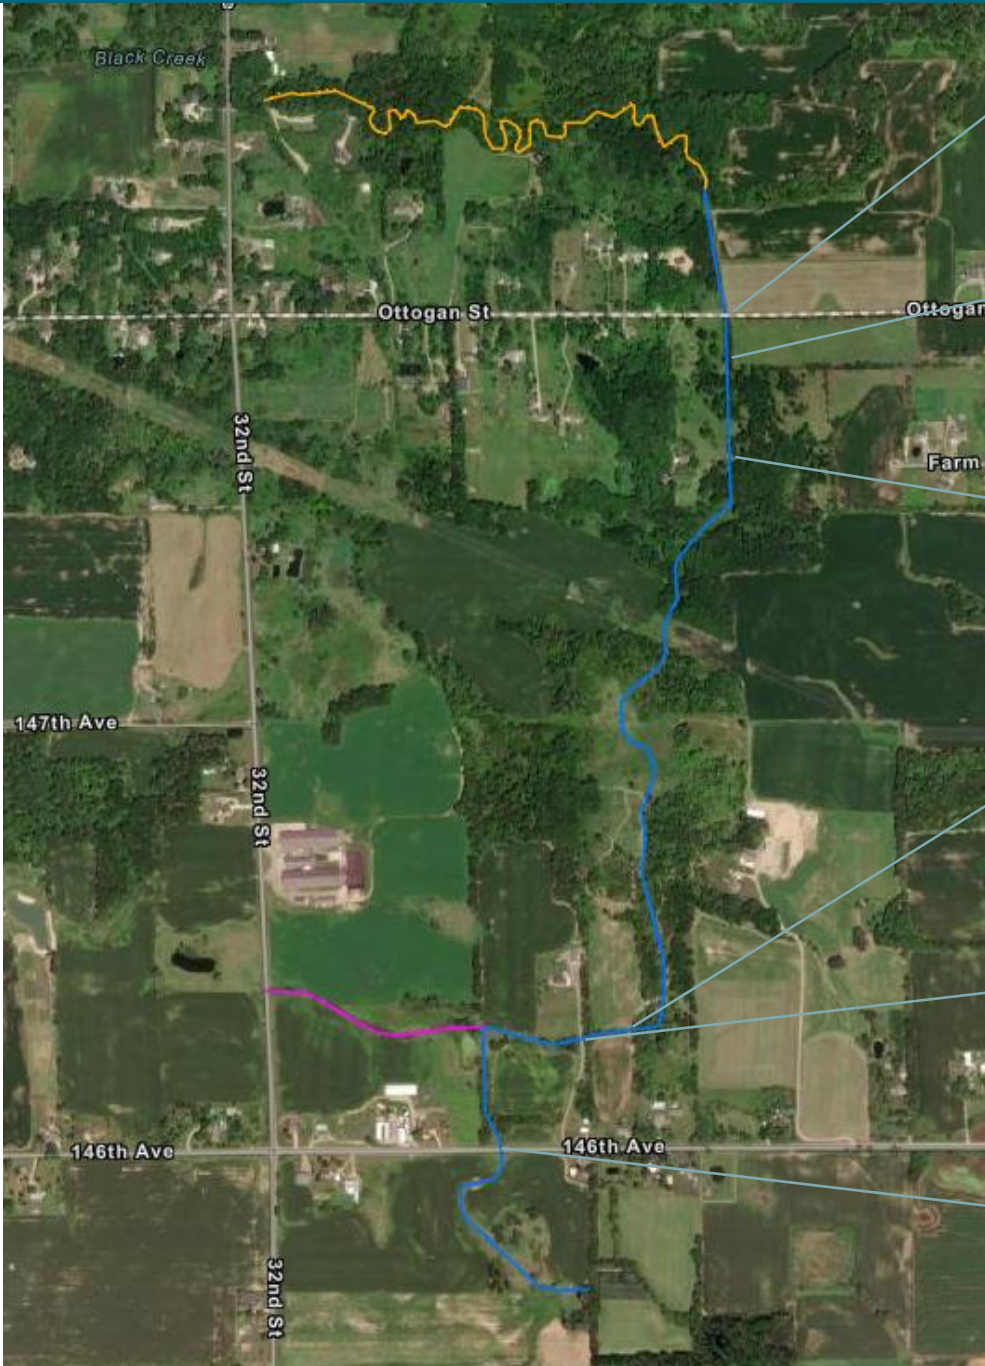
Ottogan Street, Sta 7+59
64 LF, 38"x60" Horizontal
Elliptical Concrete Pipe

Farm Crossing, Sta 10+60
44 LF, 29"x45" Horizontal
Elliptical Concrete Pipe

Farm Crossing, Sta 16+62
24 LF, 29"x45" Horizontal
Elliptical Concrete Pipe

Farm Crossing, Sta 58+25
30" CPP, Length Unknown

Farm Crossing, Sta 61+50
32 LF 36" CPP
(42" RCP per 2002 plans)

146th Ave, Sta 74+66
95 LF 36" RCP
(24" RCP per 2002 plans)

- Two county road crossings
- Four private crossings
- Crossings in generally fair to good condition
- Ottogan St crossing submerged under base flow conditions
 - Residents noted flooding during rain events
 - No evidence of settling
