October 1, 2019

Warber Drain Board of Determination

Warber Drain

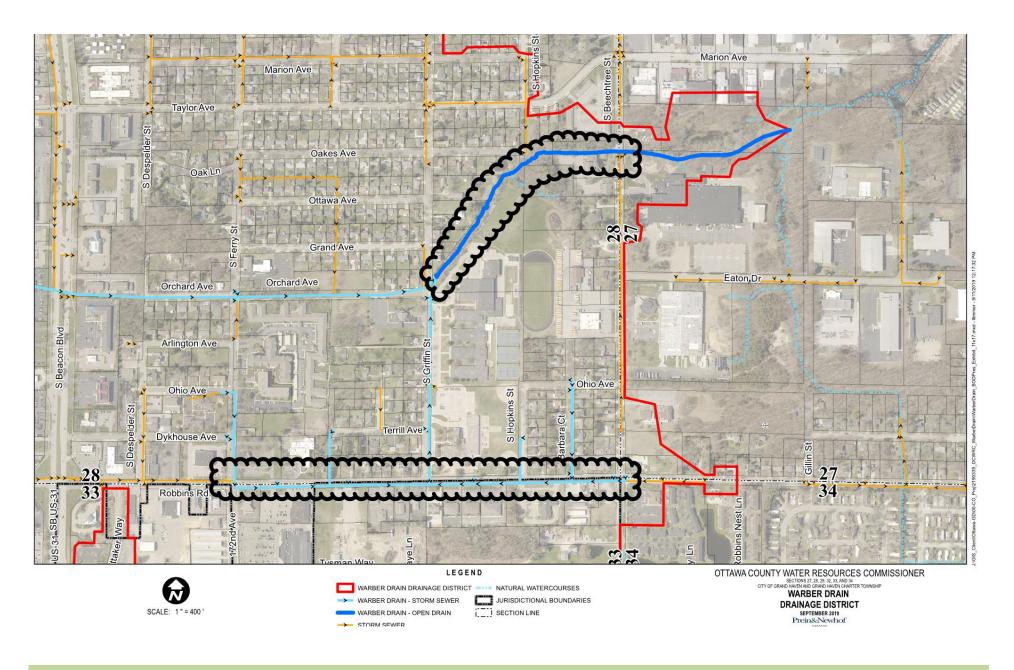
Current Known Issue Areas of the Warber Drain – Robbins Road between Ferry Street and Beechtree Street and the open drain from Griffin Street to Beechtree Street

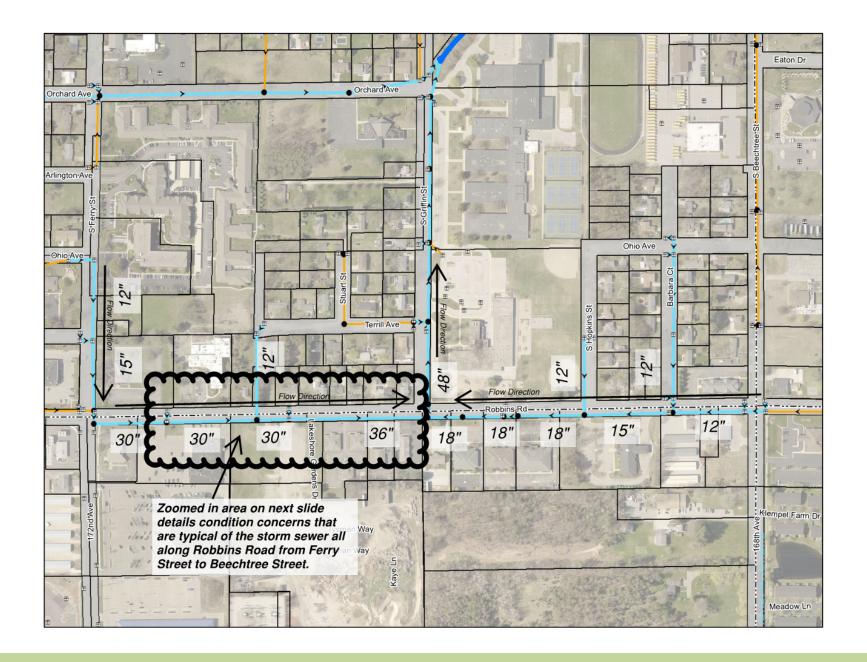
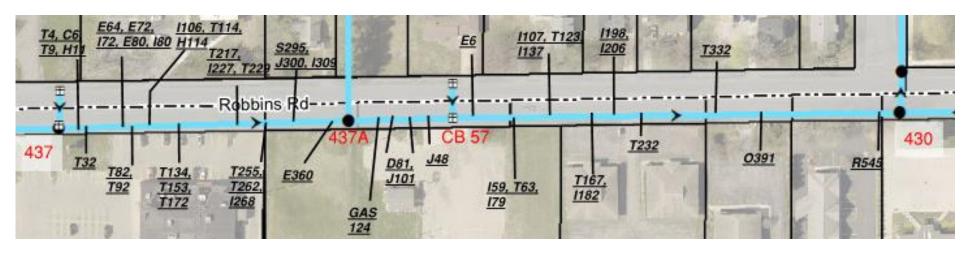
- From the surface, signs of failure and deterioration of the storm sewer have been shown, including sinkholes and settlement.
- To investigate these surface issues (sinkholes/settlement), the City of Grand Haven and OCWRC had the storm sewer televised
 - May 2017 from Ferry Street to Beechtree Street
 - August 2018 (2) sections of storm sewer closer to Ferry
- Engineering firm ENG reviewed condition of the storm sewer for OCWRC and created a report regarding the condition in February 2019

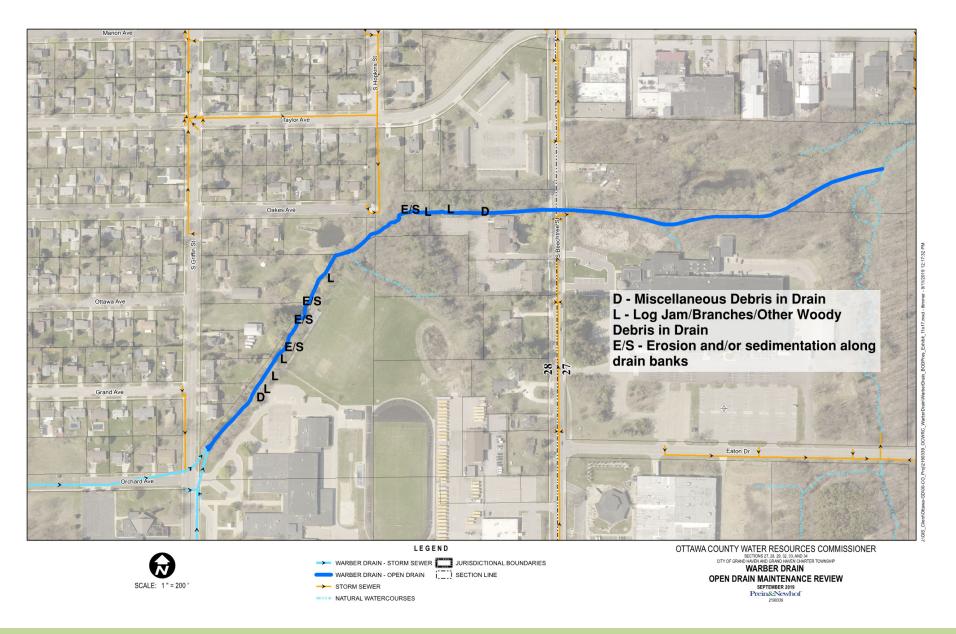
Current Known Issue Areas of the Warber Drain – Robbins Road between Ferry Street and Beechtree Street and the open drain from Griffin Street to Beechtree Street
